TCR - THE VAUX

TRAMMELL CROW RESIDENTIAL

TYPICAL ELEVATIONS

A3.1a

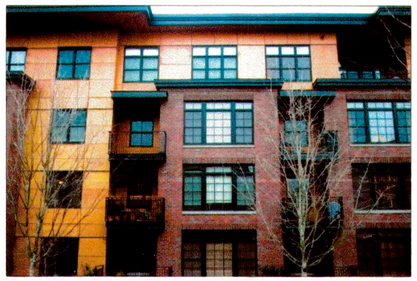
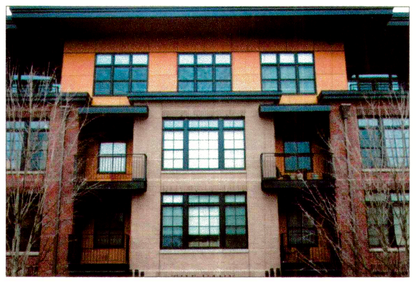
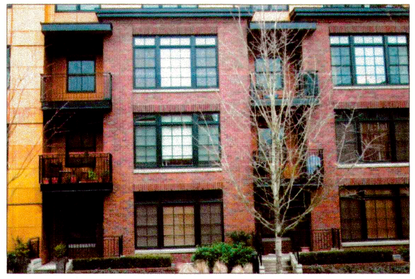
1 A3.1 EXTERIOR ELEVATION - NW RALEIGH STREET BUILDING 'A'
1/8"=1'-0"

THE AREAS INDICATED WITH DISCOLORED PANELS ARE REPRESENTED ONLY BY WHAT IS VISIBLE FROM THE STREET ON THE DATE OF THE PHOTOS. NOTE: ALL BALCONY SURFACES, SHADED SOFFITED AREAS AND INTERIOR FACES OF COLUMNS THAT WERE NOT CLEARLY VISIBLE FROM THE STREET OR COURTYARD ARE NOT DOCUMENTED AND ARE SUBJECT TO REVIEW OR DOCUMENTATION BY HOME OWNER OR DEVELOPER.

AREAS MARKED 'A' ARE OBVIOUS PANELS THAT SHOW DISCOLORATION,
THESE PANELS WOULD TYPICALLY REQUIRE REPLACEMENT.
